Offshore Inspection Findings (CG)

D8(ocs) Industry Day 26 August 2015

USCG Eighth District OCMI

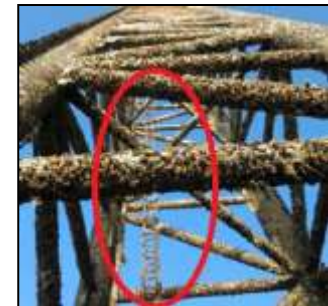
- Lifeboats #1 and #2 are lapse in the annual inspection. Last inspection was complete 12/10/2013.
- Emergency Generator Engine shutdown while under load and would not restart due to a faulty governor control solenoid.
- Several doors in stairway would not close. Provide report stating doors have been repaired.
- #2 Lifeboat had leaking hydraulic seal. Hydraulic system is the primary means of starting. Each lifesaving appliance must be in good working order at all times when unit is operational. Replace leaking seal.
- Ladders on legs are covered in barnacle growth inhibiting escape route. Recondition ladders to allow for easy escape.

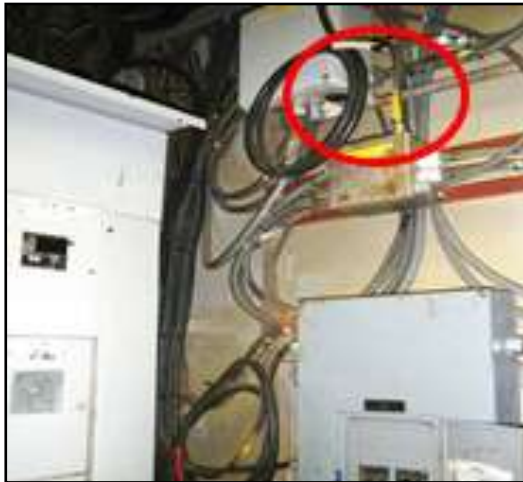
Dead end conductors in
switchboard room not terminated

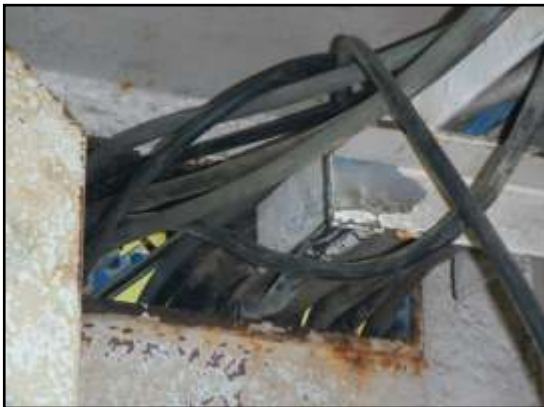
Cable penetrations missing
in watertight boundary

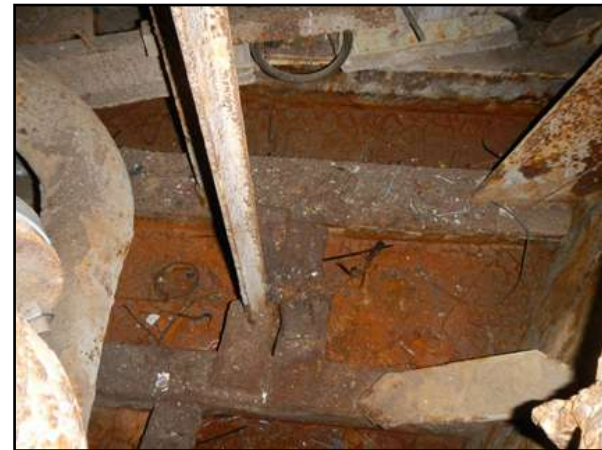
Bilge Suction inoperable-
Pontoons

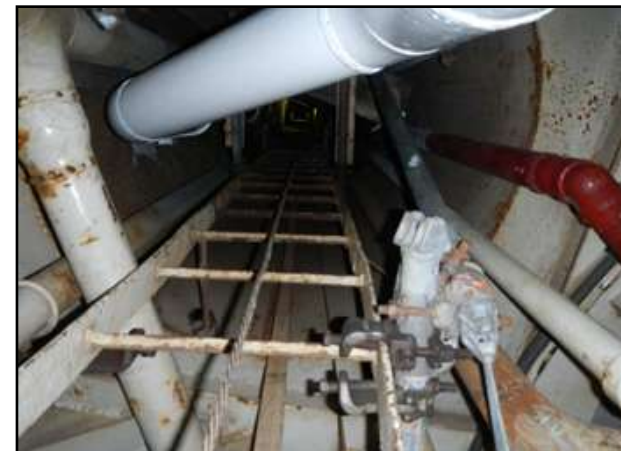
Escape routes blocked by
newly-installed pipe

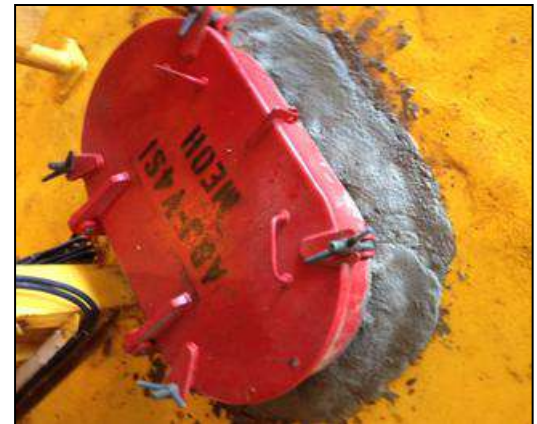
- Large concrete patch on the base of an entry hatch. Remove patch & repair according to construction portfolio.
- Found cracks in both crane windshields.
- Emergency Evacuation Plan approval letter not on board. Provide copy of letter.
- Emergency Generator's local start function in-op. Repair to original configuration.
- Gear adrift in lifeboats is taking up seating space. Relocate gear so as to not impede seating arrangement.
- Exhaust leaks at emergency generator. Repair leaks.

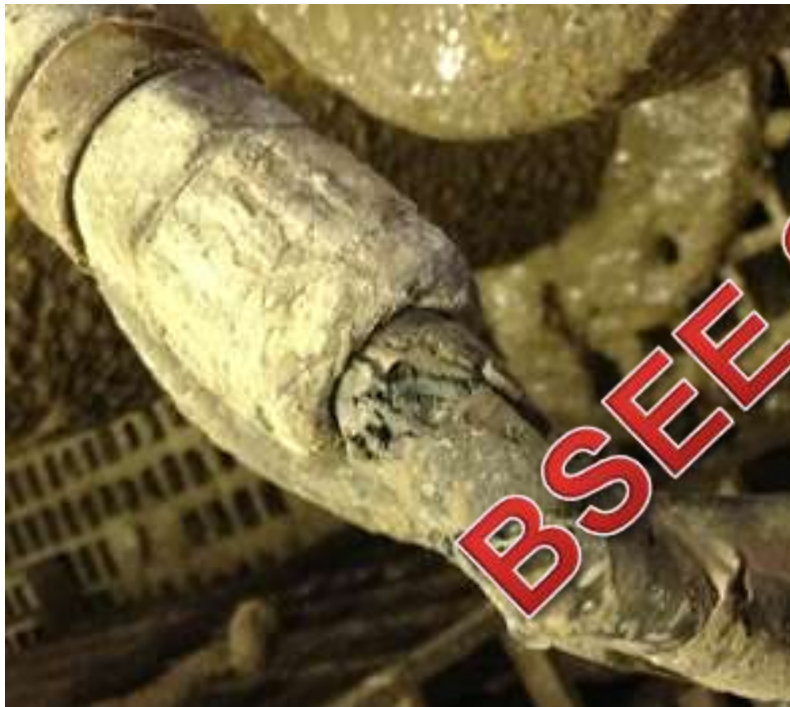
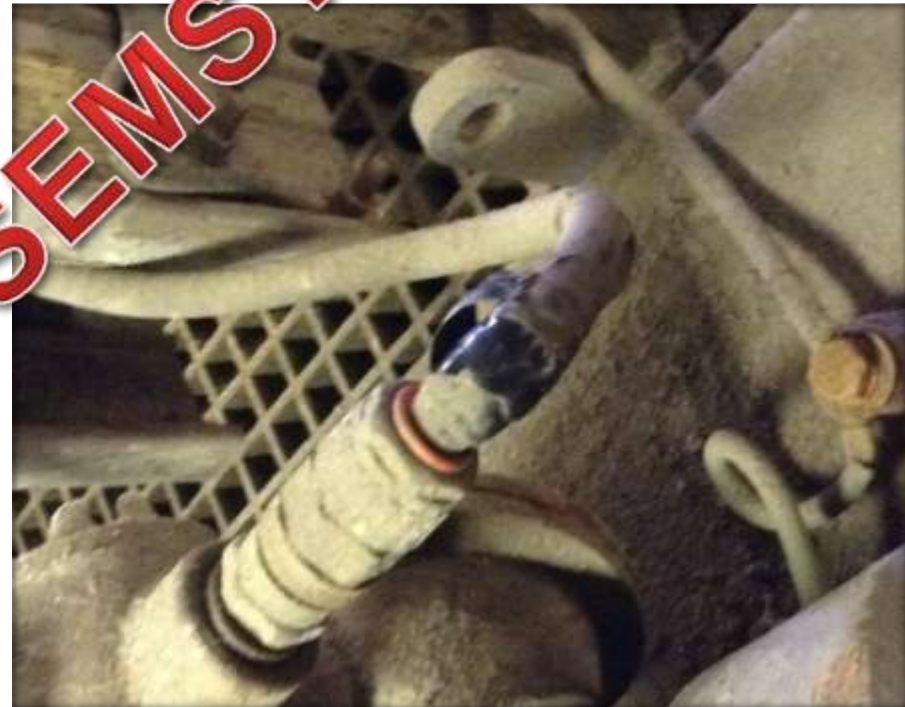
- Conductors in hazardous areas were deteriorating in outer jackets, armor. Inner jacket condition unknown.
